Czech Sport Aircraft, a.s.	SERVICE BULLETIN	Czech Sport Aircraft, a.s. Na Záhonech 1177/212, 686 04 Kunovice Czech Republic office@czechsportaircraft.com
No. SB-SC-001		Rev.: 1
Date: 2010/06/24		
Page: 1 of 3		Date: 2010/07/02

MODEL AFFECTED:	SportCruiser / PiperSport
SUBJECT:	Additional insulation of trim control / PTT switch contact
AIRCRAFT AFFECTED:	All SportCruiser aircraft produced All PiperSport aircraft produced Aircraft serial numbers S/N P1001046 and subsequent will have the subject of this bulletin accomplished prior to delivery.
COMPLIANCE:	Within 25 flight hours but not later than 31 July 2010.

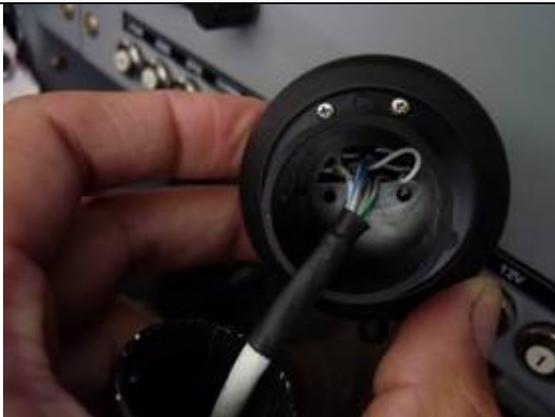
4. Cut two tie wraps in the root area of the control stick.

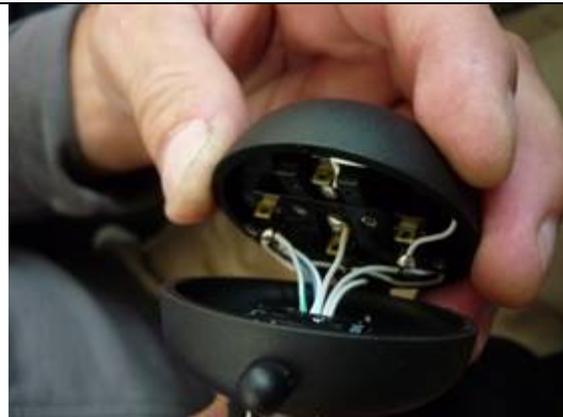
5. Lift the stick grip head up and remove four screws on its bottom side.

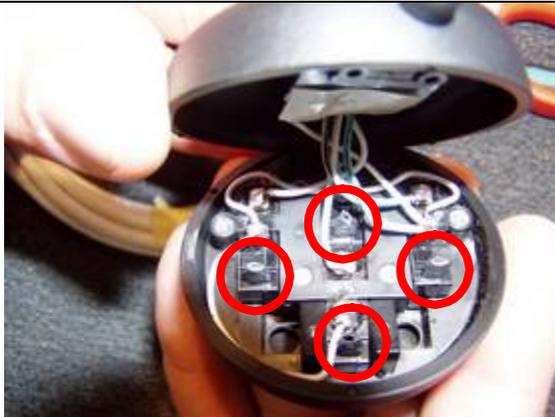
6. Carefully open the stick grip head. Inspect contacts and wires for quality of soldering, amount of solder on contacts (should be compact solders, large blobs are not acceptable). Inspect the insulation of wires for obvious wear. In case of damage, repair in accordance with FAA AC 43.13.

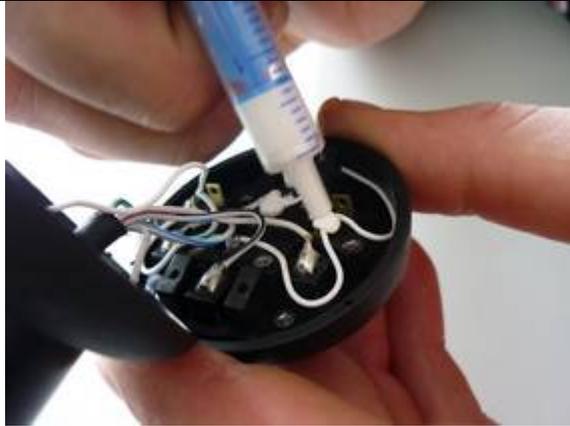
8. Fill up a small amount (10 ml) of silicone adhesive into a syringe if not using a smaller 82ml tube.

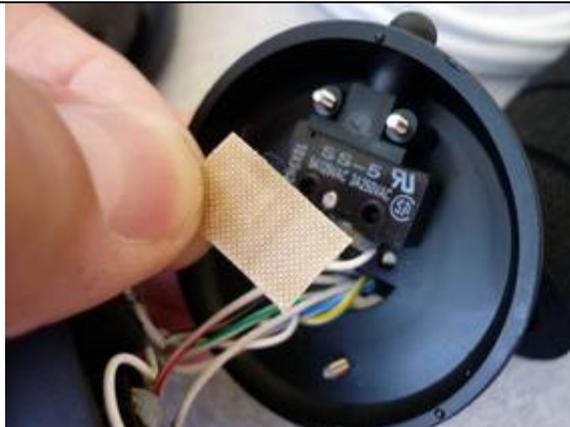
9. Dab a small drop of silicone adhesive on each of the contacts. Do not forget the PTT switch contacts (on lower part of the stick grip head) and fix heat shrinkable tubing on any unused contacts. Let it cure in accordance with the silicone adhesive manufacturer's technical data.

10. As soon as the silicone adhesive is cured, check the contact insulation and repeat step 9, if necessary. The electrical contacts must not be exposed in any place where there may exist a possibility of touching against another contact or wire. If there is any excess silicone adhesive present, cut this off using a sharp razor or knife so that it does not prevent the stick head being later closed (it is a tight space).

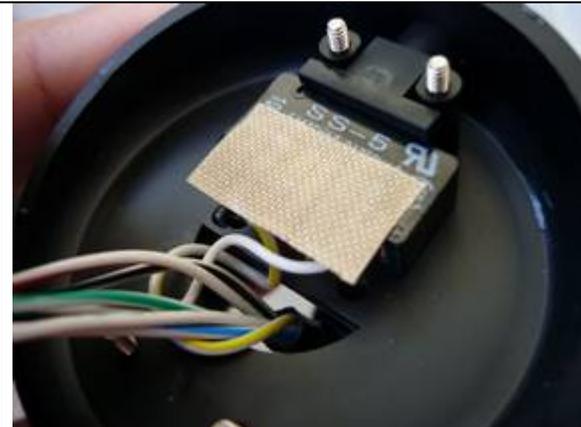
11. Cut a rectangular shape of PTFE glass cloth adhesive tape, of dimensions 10 x 20 mm. Note glass cloth tape is more resistant to tearing than regular PTFE tape.

12. Stick the adhesive tape on the PTT switch, on the lower part of the stick grip head so that it overlaps the PTT switch body and protects soldered (and now insulated) contacts.
